NSERC Alliance Project 'Next-generation Wood Construction'

First Annual Conference - 2024

Functional Recovery Assessment of CLT shear-wall and Glulam Moment-resisting Frame (CLTW-GMRF) System

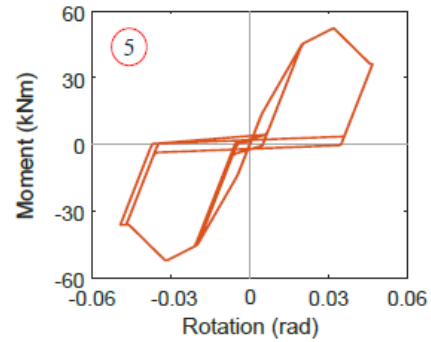
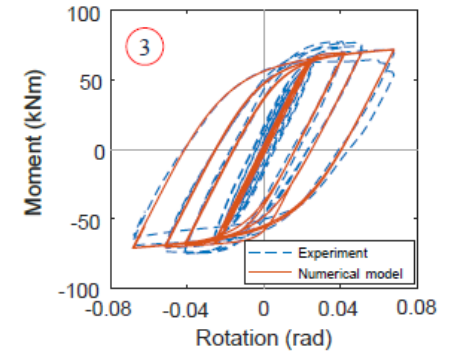
Fig: CLTW-GMRF system components

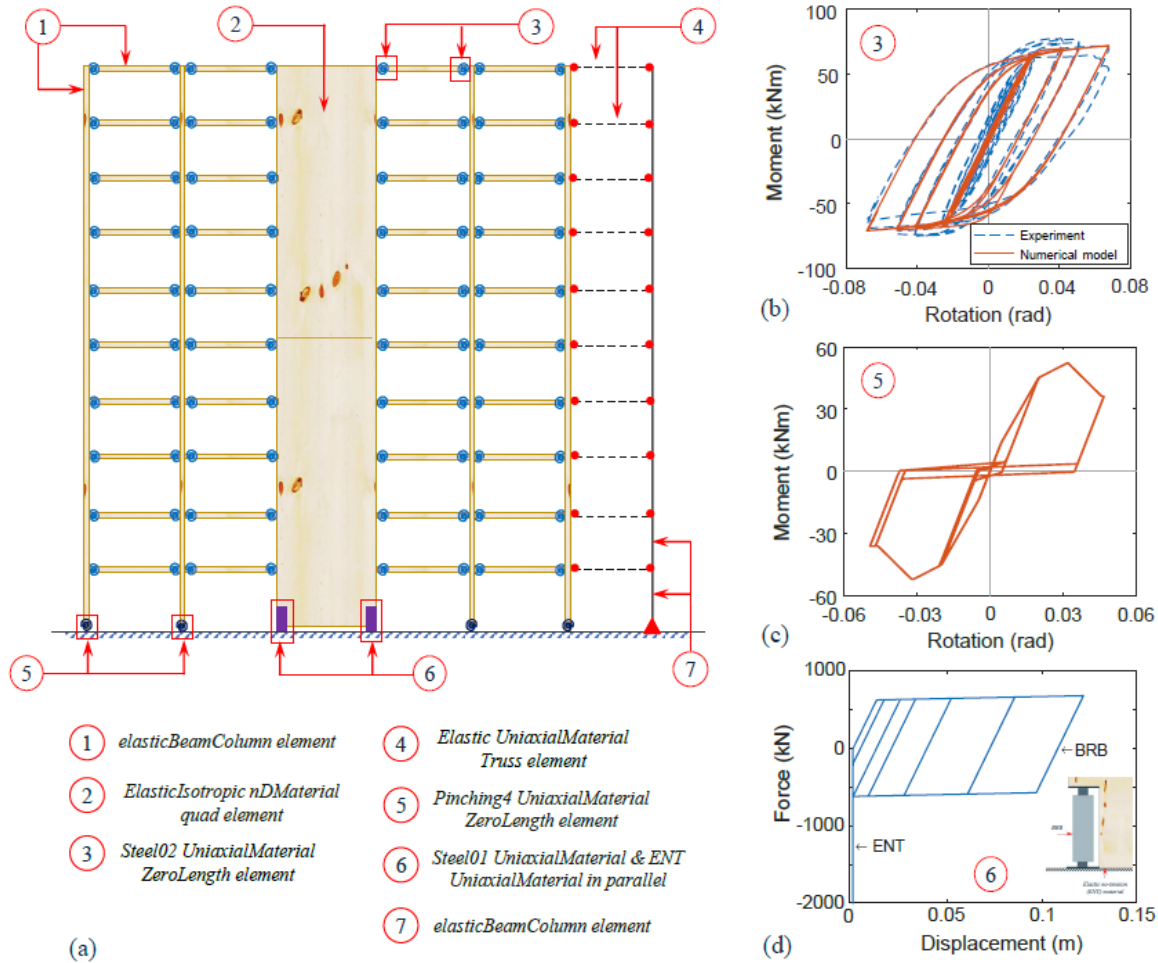
Fig: Numerical model: (a) system, (b) BCJ, (c) CBJ, and (d) hold-down (Teweldebrhan and Tesfamariam 2023b)

* **BCJ**: Beam – column joint, **CBJ** : Column – base joint

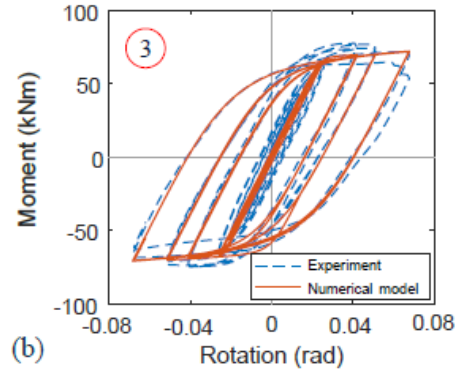
Beam-Column Joint

Damage States: Joint Rotation (Wakashima et al. 2010, Gohlich et al. 2018)

- Around 0.02 rad, the joint started to show out-of-plane local buckling of the web,
- Around 0.03 rad, the joint showed excessive out-of-plane local buckling of the web,
- Around 0.04 rad, local buckling of the flanges occurred along with gap openings between the columns and the column side plates,
- Around 0.05 rad, complete failure of the joint system.

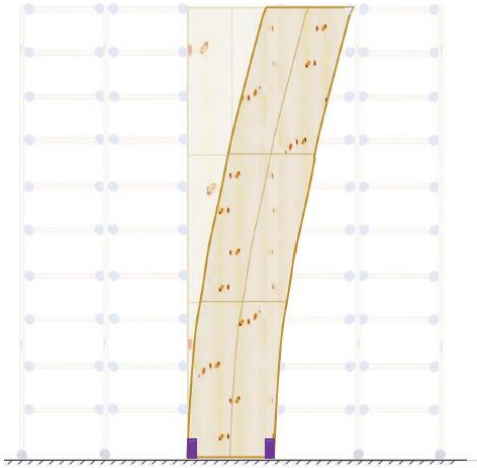
CLT Balloon Wall

Damage States: Connection Failure (Shahnewaz et al 2021; Tian et al 2023)

- DS1 indicates that bolts come loose.
- DS2 indicates plastic deformation of steel joints;
- DS3 indicates fracture of bolts or steel plates;

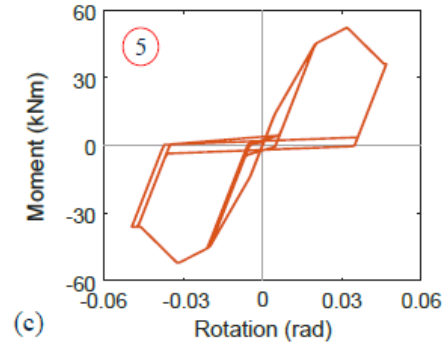
Column-Base Joint

Damage States: Joint rotation (Mori et al 2015)

- DS1 (around 0.0045 rad), the joint might exhibit partial tearing of the steel sleeve or potential crack initiation at the intersection of the steel sleeve and steel plate.
- DS2 (around 0.02 rad), the lagscrewbolts undergo a non-linear (post-yielding) deformation.
- DS3 (around 0.032 rad), characterized by a near-complete pullout of the lagscrews from the timber column, signaling an imminent loss of vertical load resistance.

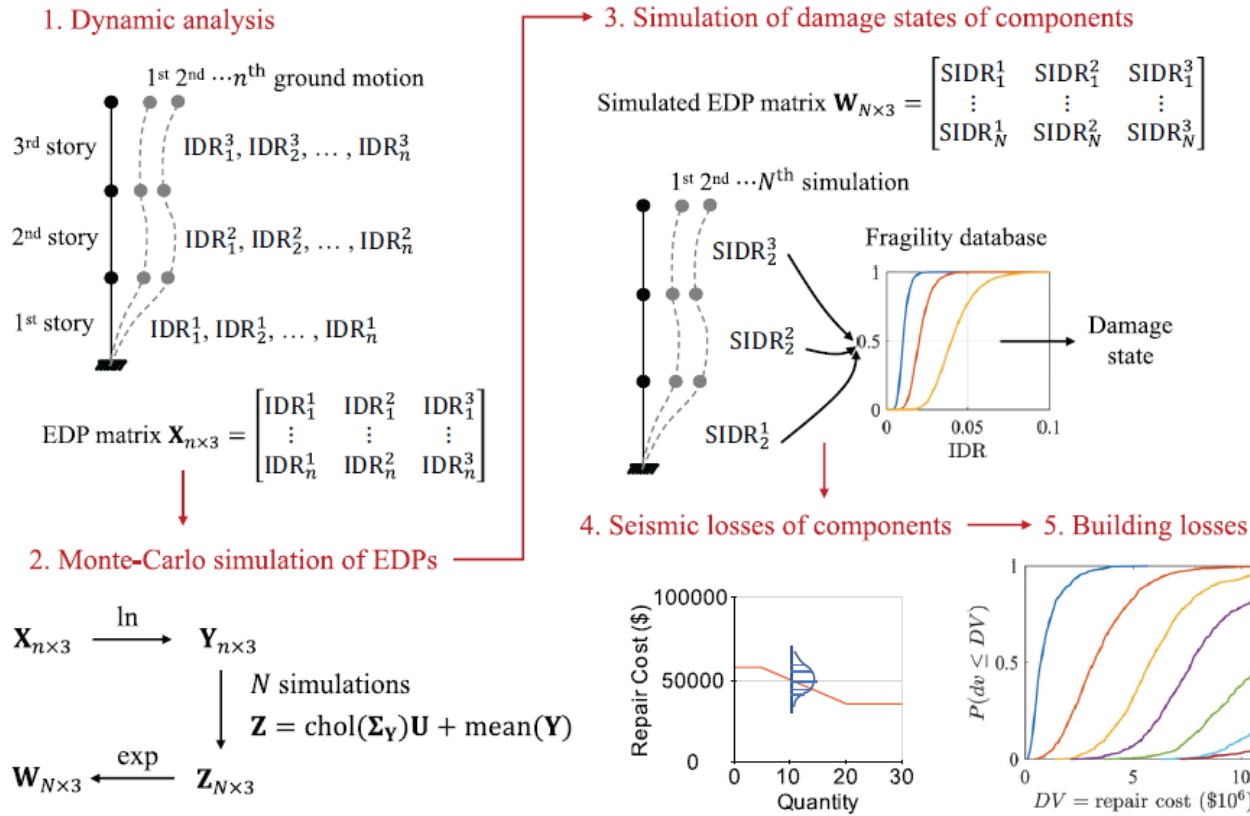
Fig. Seismic loss assessment of a structural system (You et al. 2023)

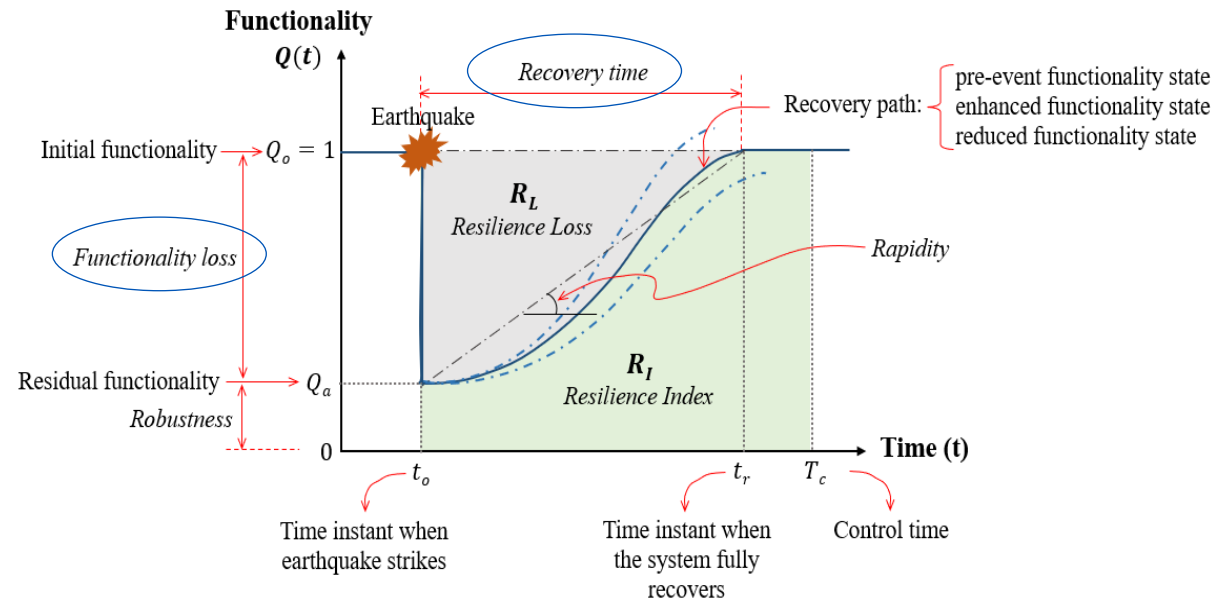
Fig. The concept of resilience triangle (Adapted from Bruneau et al. 2003)

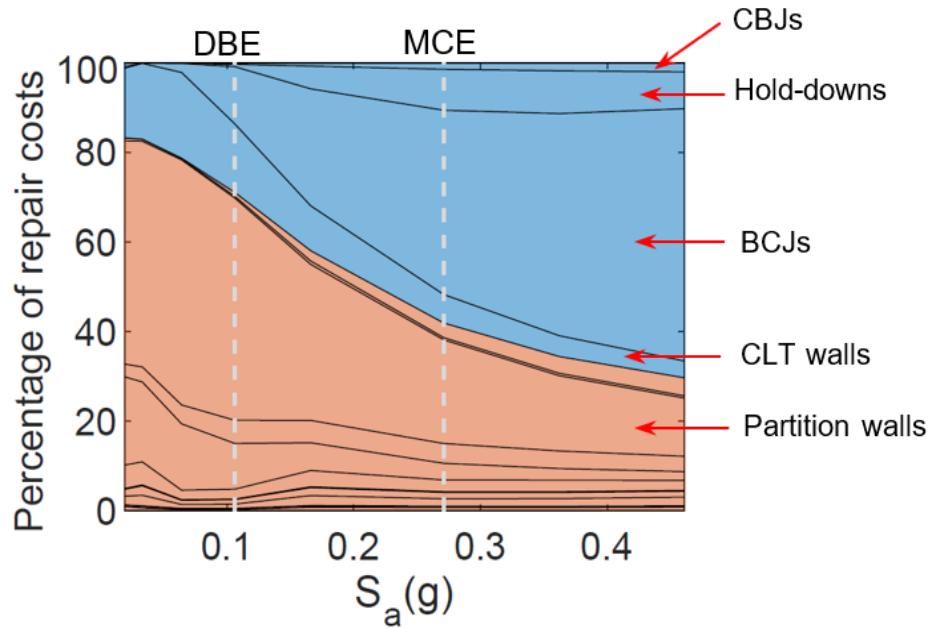
Repair cost percentage contribution from different components

- Non-structural components significantly influence repair costs at lower seismic intensities, but as the intensity increases, structural components become the primary contributors to the costs.

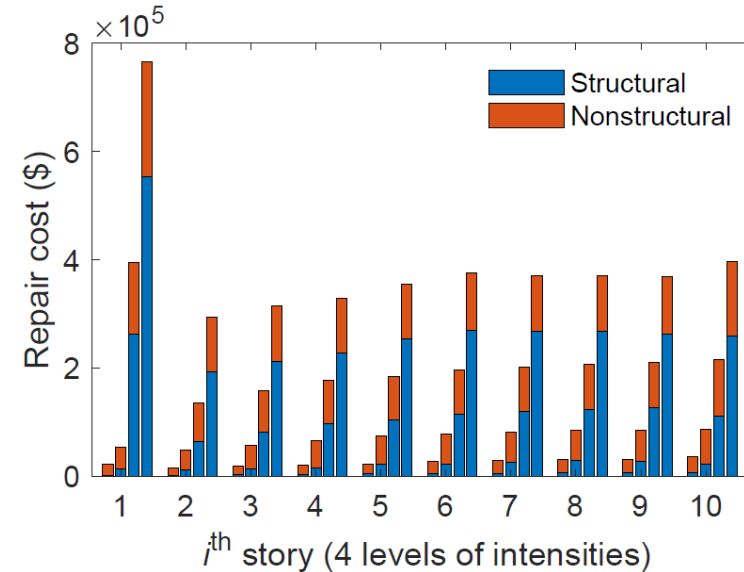
Repair cost per floor level

*Four bars represent the result from four GM intensity levels with T_R of 98, 475, 2475, and 9975 years.
